## AN INVESTIGATION OF HUMAN LONG BONE FRACTURE PATTERNS DURING TRAUMATIC AMPUTATIONS FROM MOVING RAILROAD EQUIPEMNT

Brian T. Weaver (1,2), Mark Davison (1), Steve Rundell (1), Eric Meyer (3)

(1) Explico Engineering Co.  
Novi, MI, USA

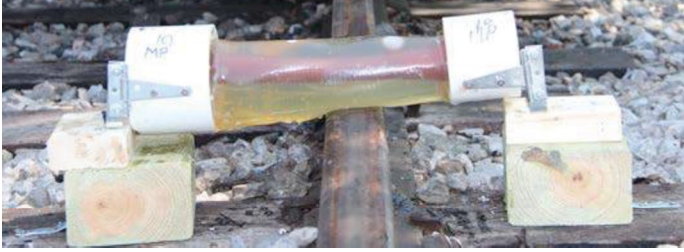
**Figure 1: Illustration of test setup**

Each leg was secured on top of, and perpendicular to, the rail by fastening each pot to wooden blocks located on either side of the rail (Figure 1). These blocks were rigidly fixed to a railroad tie so the proximal end of the femur was 9 inches from the gauge side (i.e. inside) of the track (Figure 2). Each pot was fastened to the wooden blocks via hinges to allow the specimen to swing away from the locomotive after bone fracture occurred. Each bone was run over by the leading wheel of a locomotive (GE B-B-100/100-2GE733) traveling approximately 5 mph. The orientation of the legs was precisely controlled. Testing included two orientations (supine/prone) and two locomotive directions (medial/lateral). Fracture patterns were recorded and analyzed following each test.

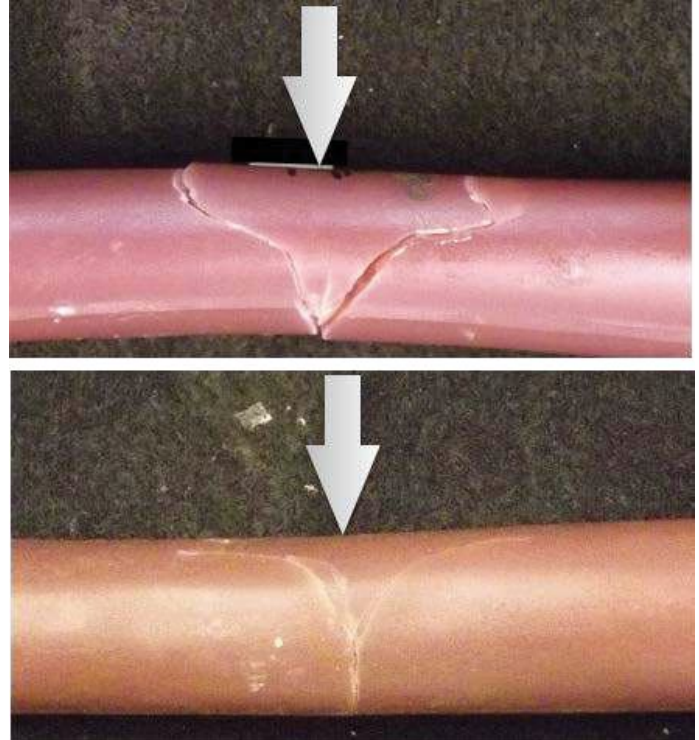
**Figure 3: Illustration of the typical fracture patterns observed. Top: Butterfly wedge pattern; Bottom: Oblique / incomplete wedge pattern. Arrow indicates direction of impact**

All 12 specimens fractured as a result of contact from the railroad wheel. The fracture of all 12 specimens was located on the gauge side the rail as a result of contact from the flange on the railroad wheel (Figure 2). None of the specimens were crushed. The most common fracture pattern was a butterfly wedge (n=6) (Figure 3). Interestingly, the other cases (comminuted; n=3, oblique; n=2, transverse; n=1) produced similar “Y” shaped crack propagation patterns, but the wedge fracture was incomplete (Figure 3). The fracture pattern was dependent on the orientation of the femur and direction of locomotive movement. Specifically, the “Y” shaped fracture pattern opened up towards the flange in all 12 specimens (Figure 3).

The results presented here are similar to previous experimental studies involving bending of human cadaveric long bones, which also generated similar patterns of fracture, including the typical butterfly, oblique and transverse fractures [4]. During bending, the fracture initiates on the tensile side and propagates to the neutral axis before bifurcating on the compression side to form the characteristic “Y” shape [5]. In the current study, the flange contacted the bone and attempted to push the bone out of the way resulting in 3 point bending.
